Latest silicon ladder

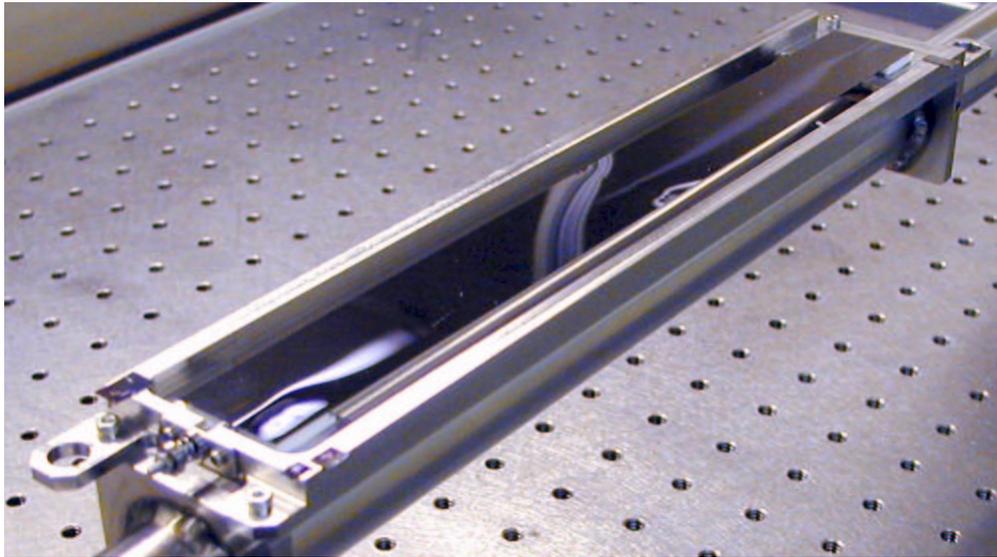
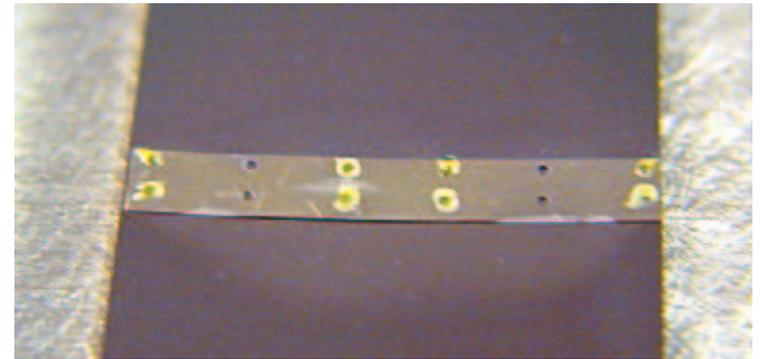
- Silicon ladder suffers distortions
 - This is due to the different co-efficients of expansion

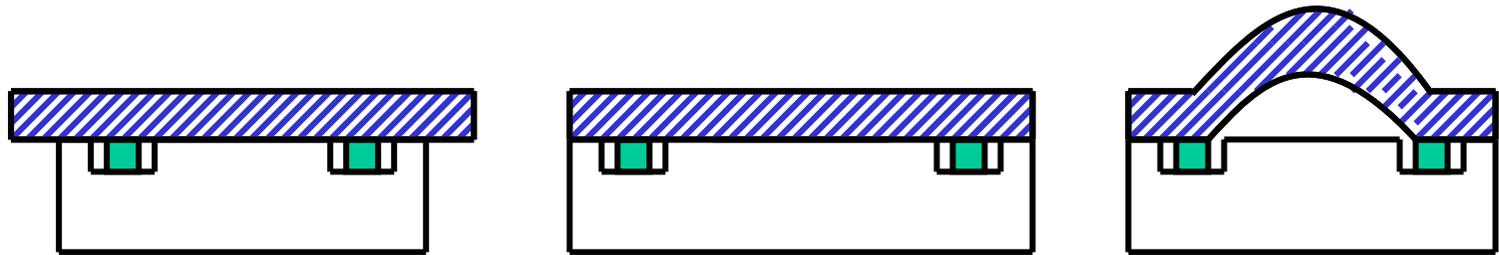
Ladder at room temp

At 90 deg C

After cooling back to room temp

Problem needs to be solve as will return when trying bump bonding

Suggest making one channel to put glue down
