## **Fan-in Tests**

**A.Chilingarov**

**Lancaster University**

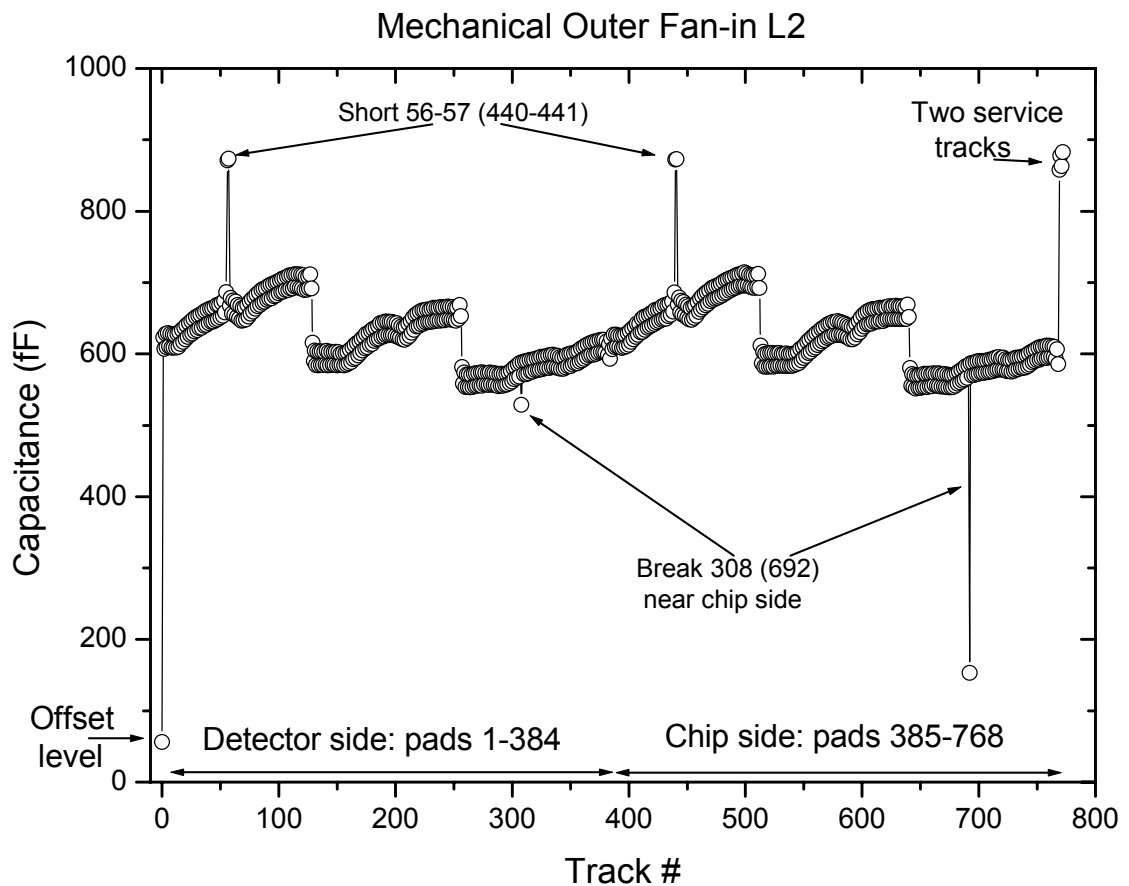
The fan-in is placed on the chuck and for each track its capacitance to the chuck is measured twice: at the detector side and at the chip side pads. Pad numbering is shown at the plot. The capacitance for two service tracks is also measured (pads 769-772). The offset C value is defined by positioning the probe needle outside the fan-in area (pad 0).

Shorts between tracks appear as an increased C for two adjacent pads at both sides. A break leads to a drop in C at both sides and at least for one side the drop is more than 50%.

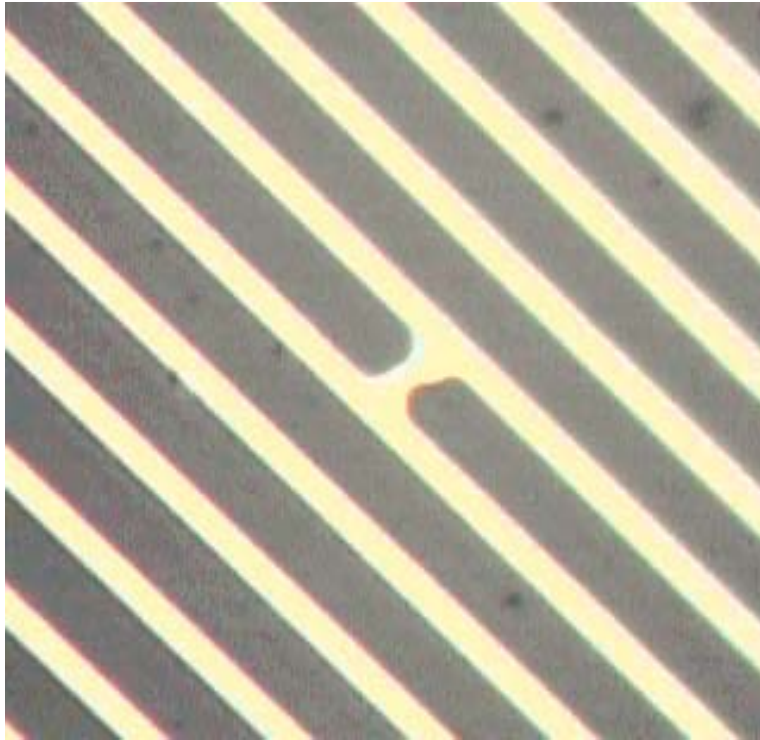
For this fan-in rejected previously by a visual inspection the sources of the break and the short were clearly identifiable visually (see below).

**Mechanical fan-in L2: short between tracks 56-57**

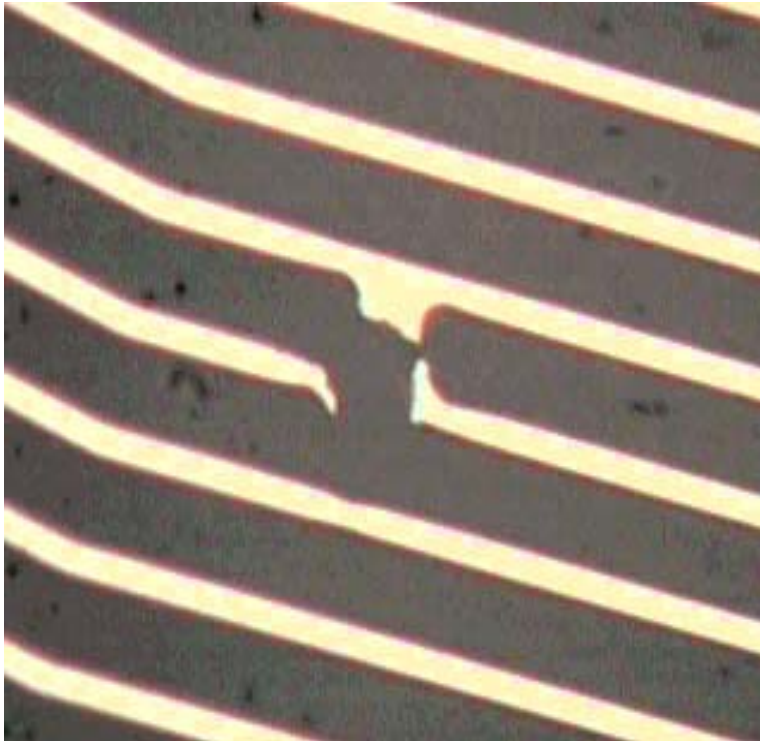
**Mechanical fan-in L2: break at track 308**

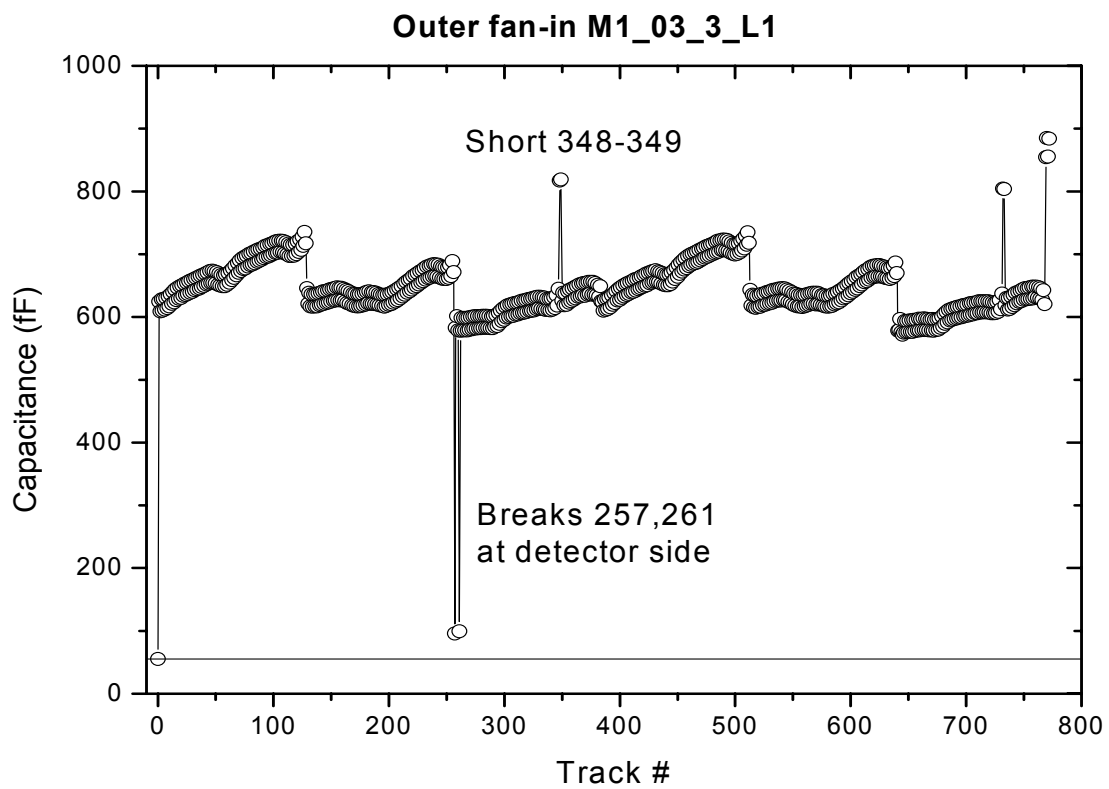
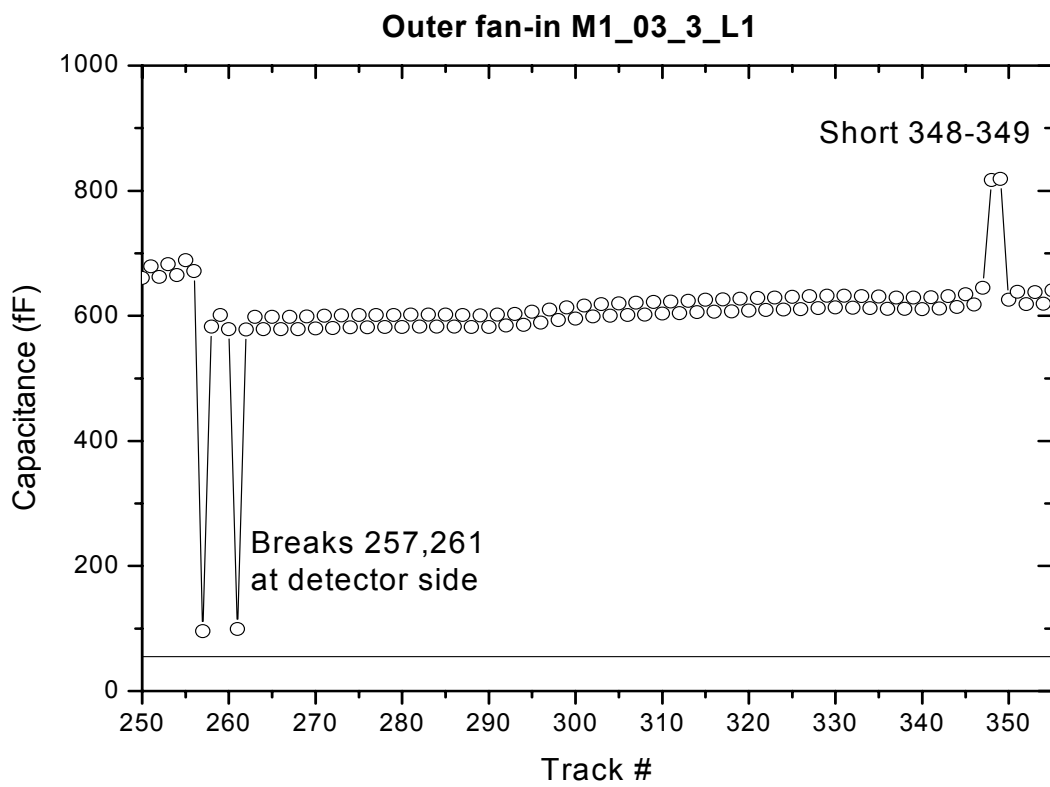
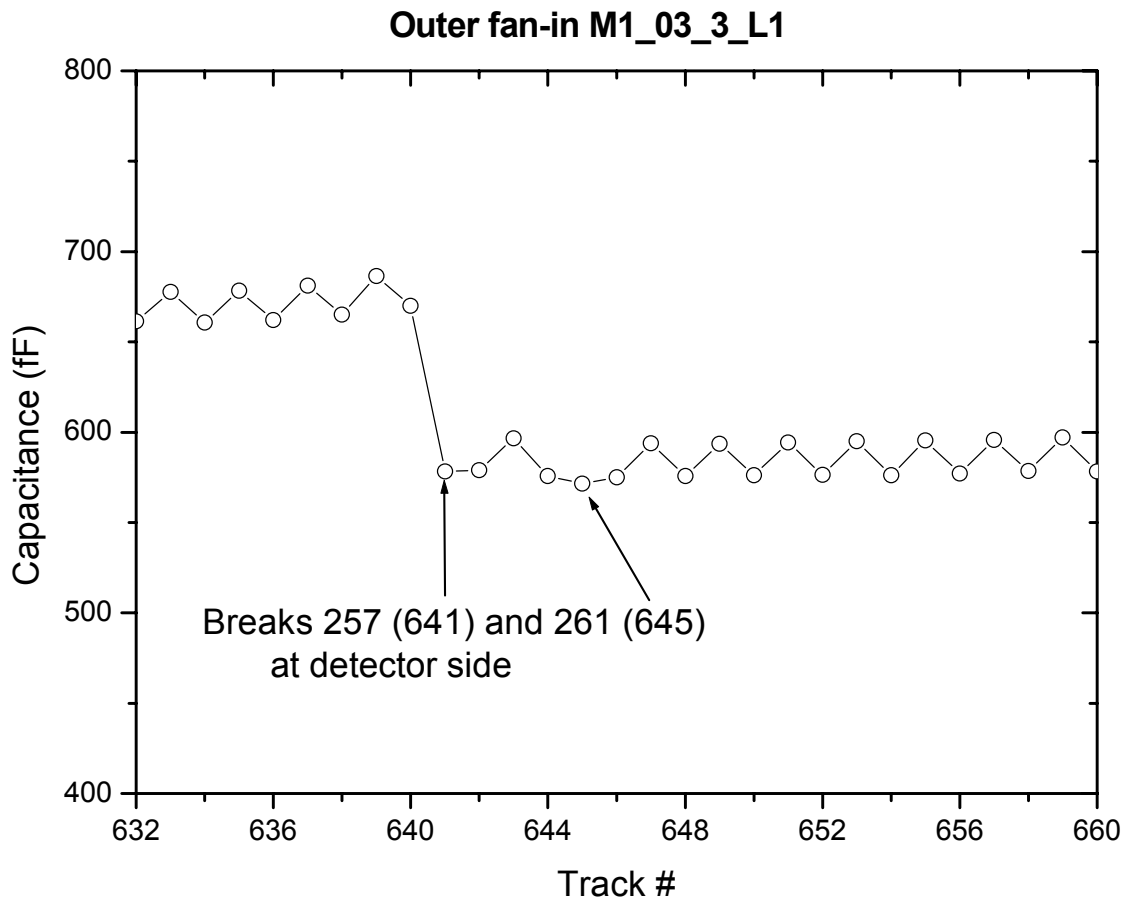
The break is so close to the detector side that the drops in C at the chip side are noticeable, but just. This explains why the measurements from both sides are necessary for reliable testing.

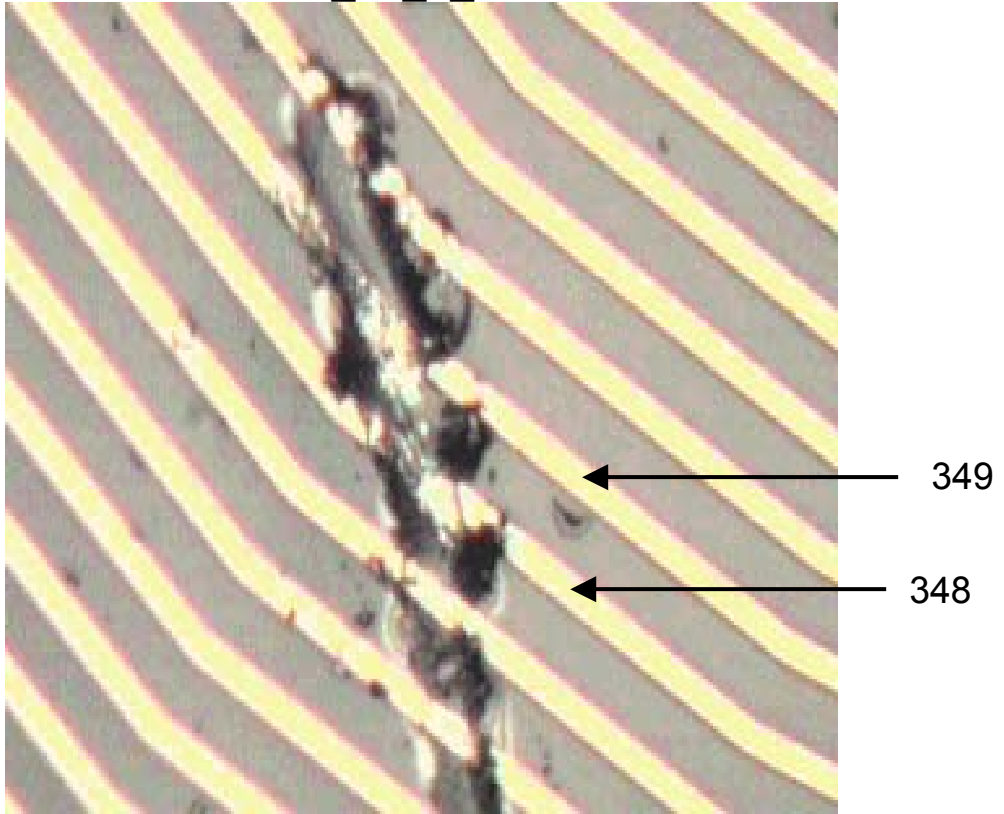
Optical inspection revealed the reasons for the short and breaks as shown below. Note that the strip 259 shows no break electrically in spite of the scratch through it looking identical to those at strips 257 and 261. A similar scratch at ~ pad 350 did not lead to any electrical defects. Hence not all suspiciously looking defects lead to the electrical defects.

**Outer fan-in M1\_03\_3\_L1: short 348-349**

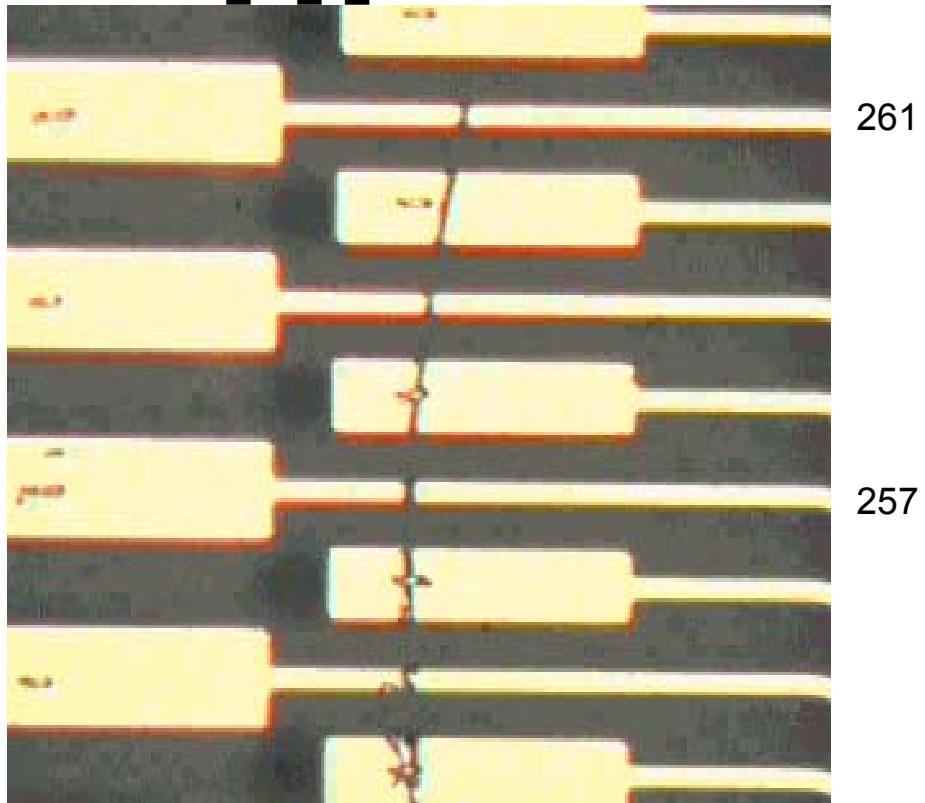
**Outer fan-in M1\_03\_3\_L1: scratch at detector side**

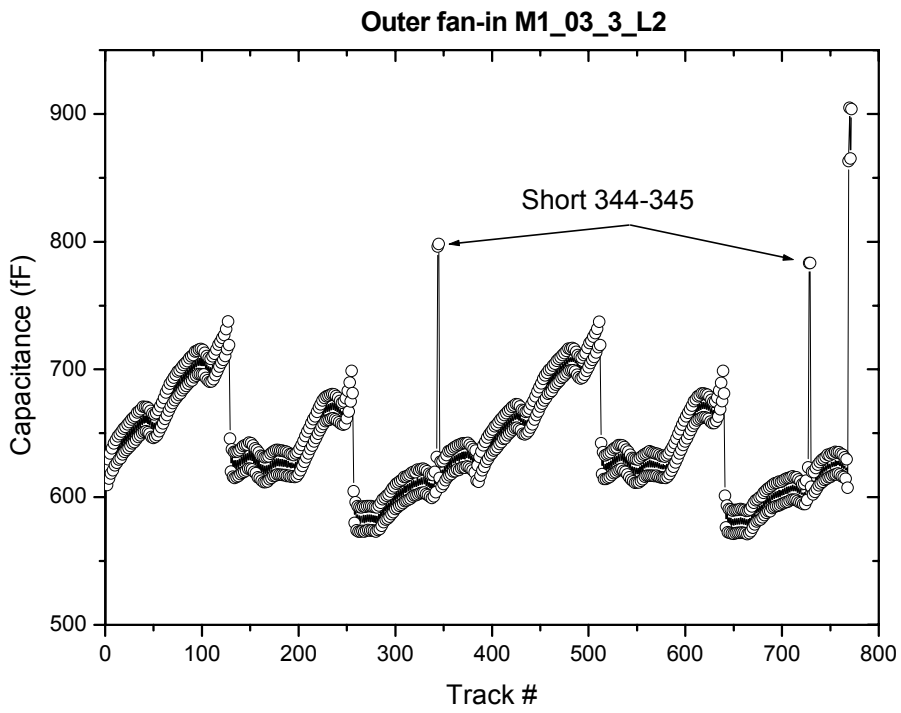
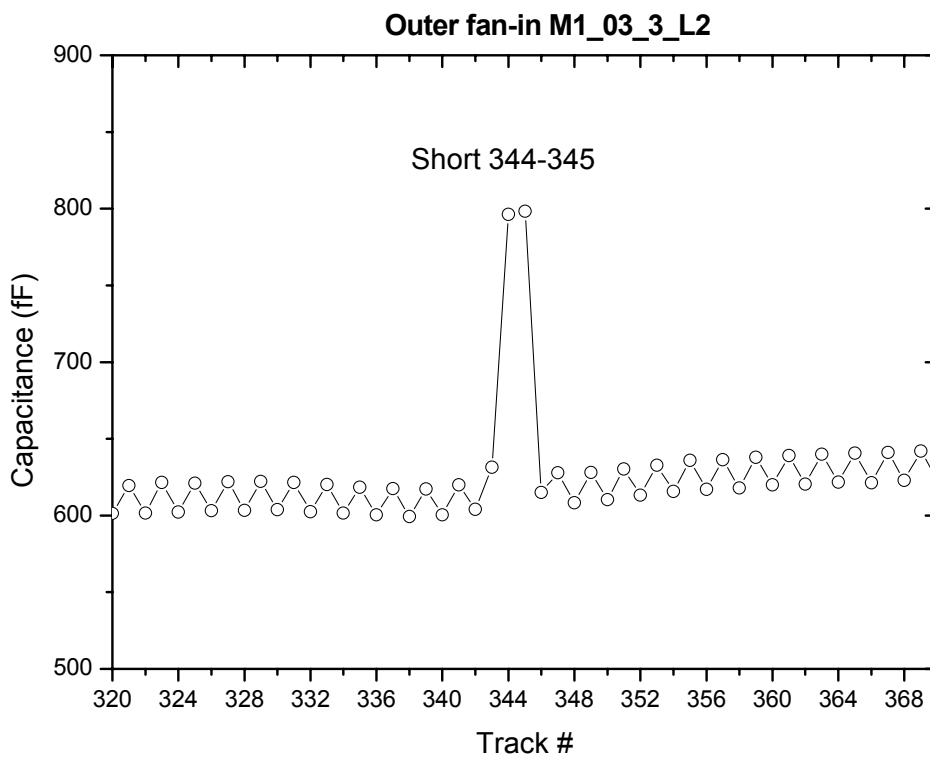
Visual inspection did not reveal any obvious reasons for the short at this fan-in. Hence not all electrical defects can be found visually.
