H. Henschel, I. Tsurin		
Title		
VME interface and serial controller		
Size	Document Number	Rev
	BST Pad trigger system: Interface card	1
Date:	Thursday, September 22, 2005	Sheet 2 of 5

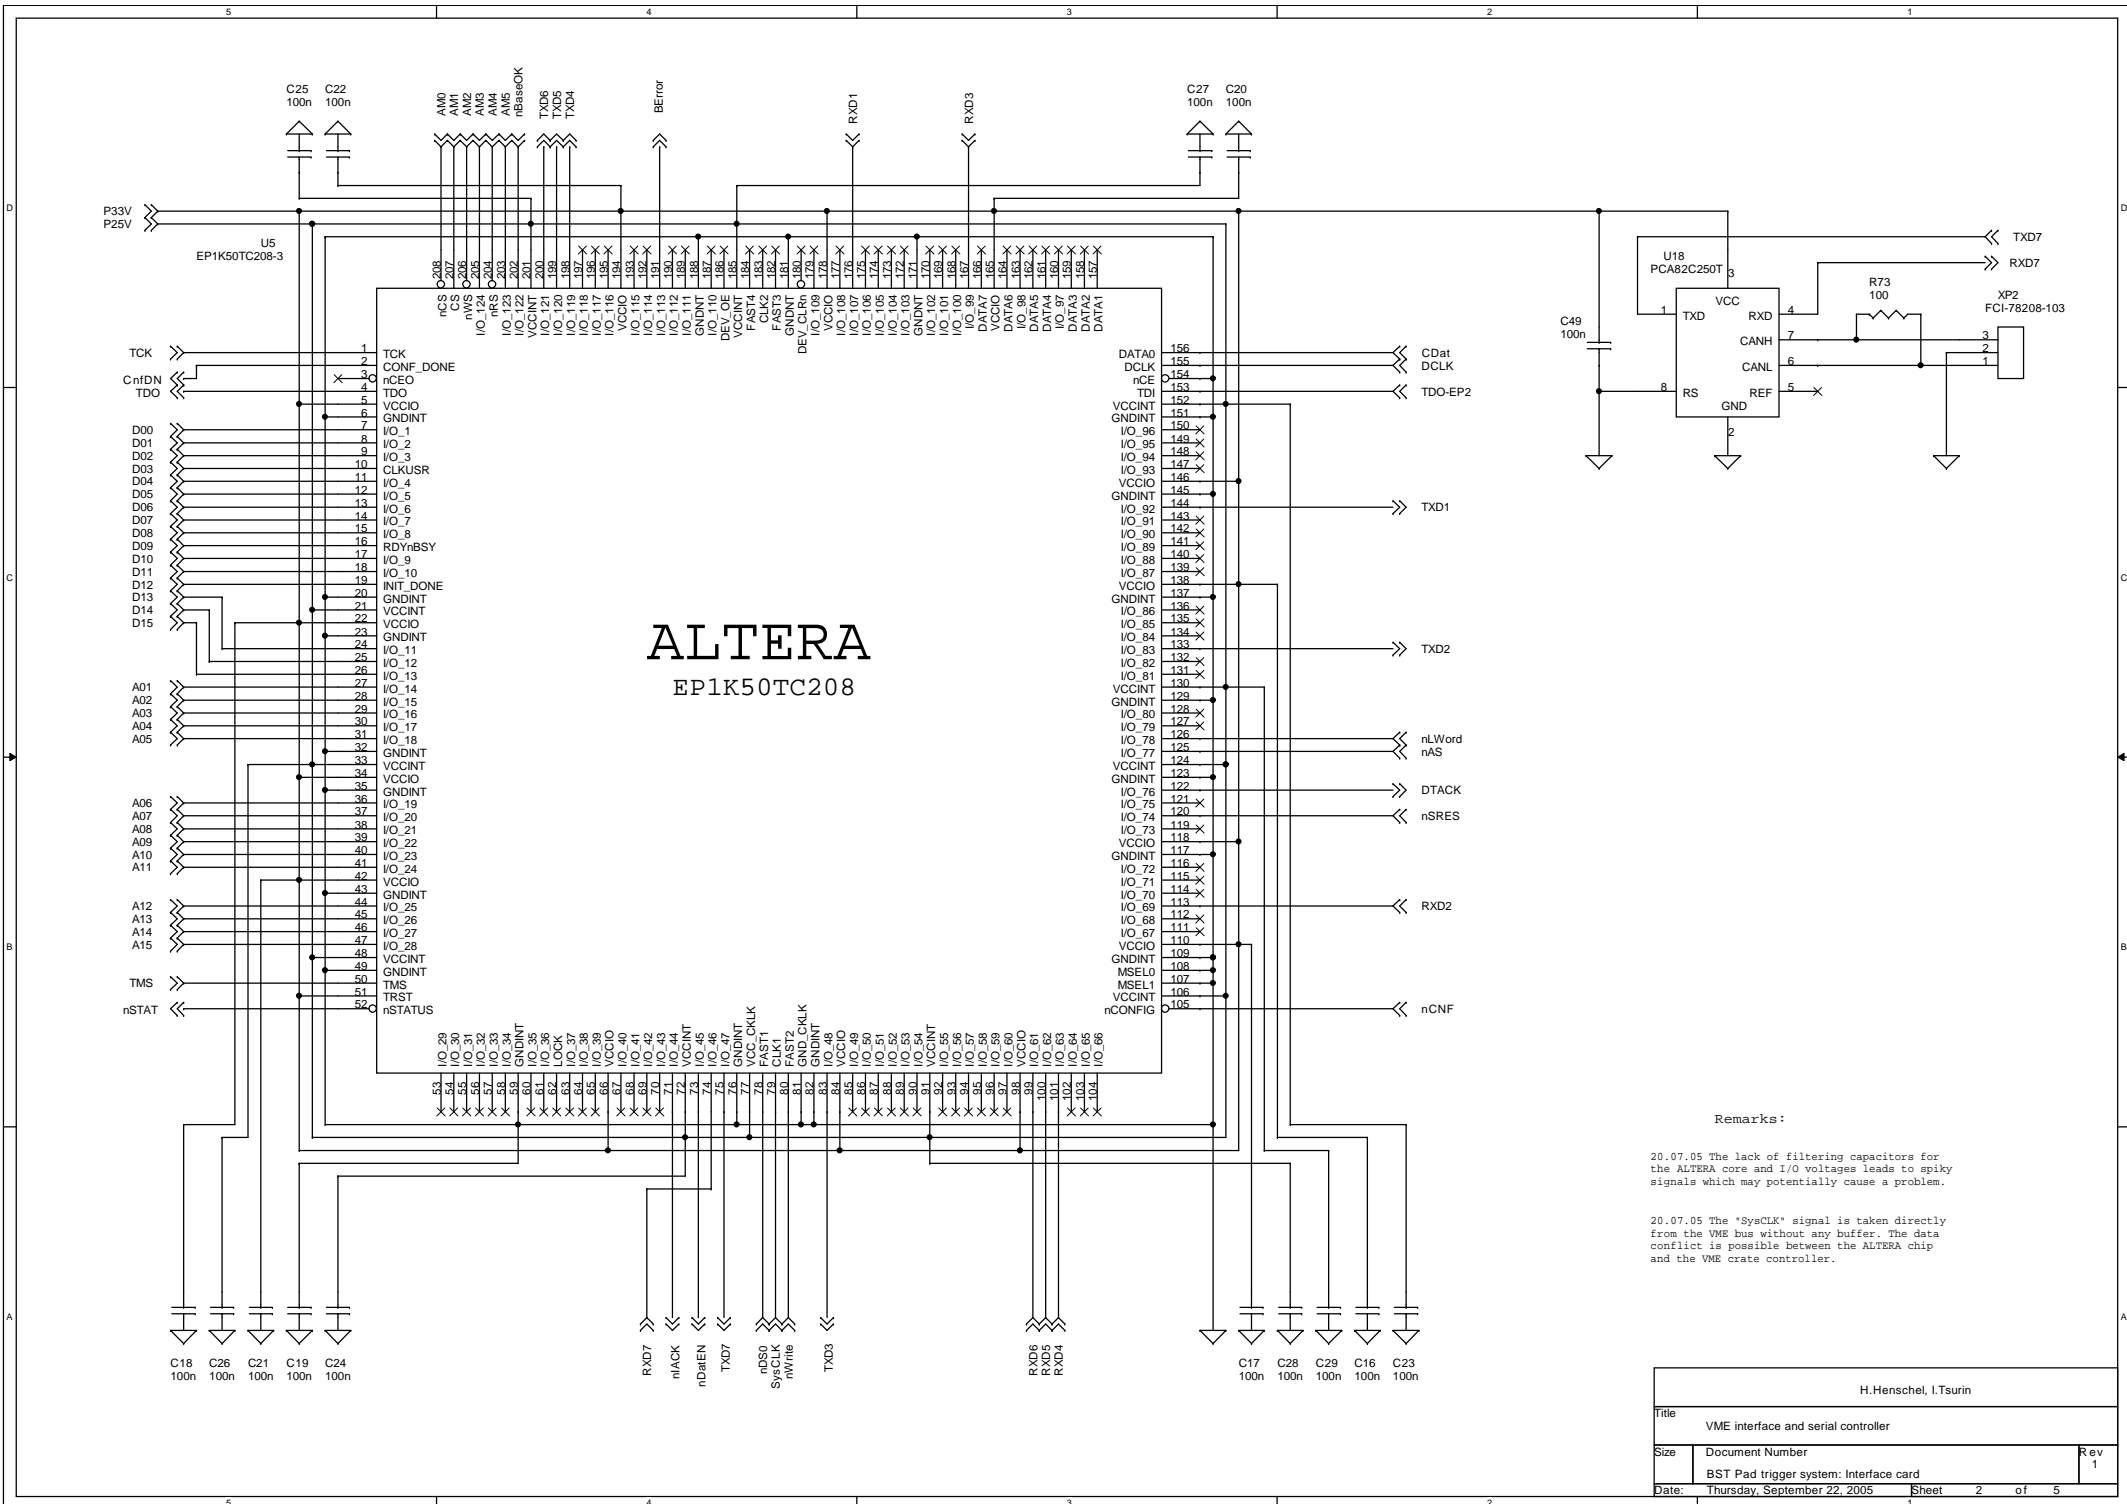
ALTERA
EP1K50TC208

20.07.05 The lack of filtering capacitors for the ALTERA core and I/O voltages leads to spiky signals which may potentially cause a problem.

20.07.05 The "SysCLK" signal is taken directly from the VME bus without any buffer. The data conflict is possible between the ALTERA chip and the VME crate controller.
