Modules on Disk 9

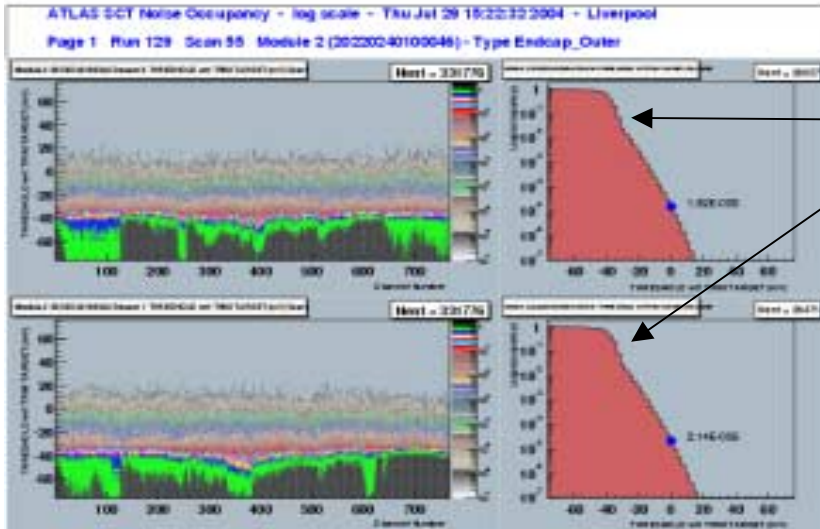
- So we are nearly able to recover the modules operation with the links in, except that we are also seeing the following:

- Discontinuities are seen on modules on the Disk.
- It is occurring at $\sim 0.24fC$
- It is independent of trigger rate, optical power or whether the Redundancy Links are in or not.

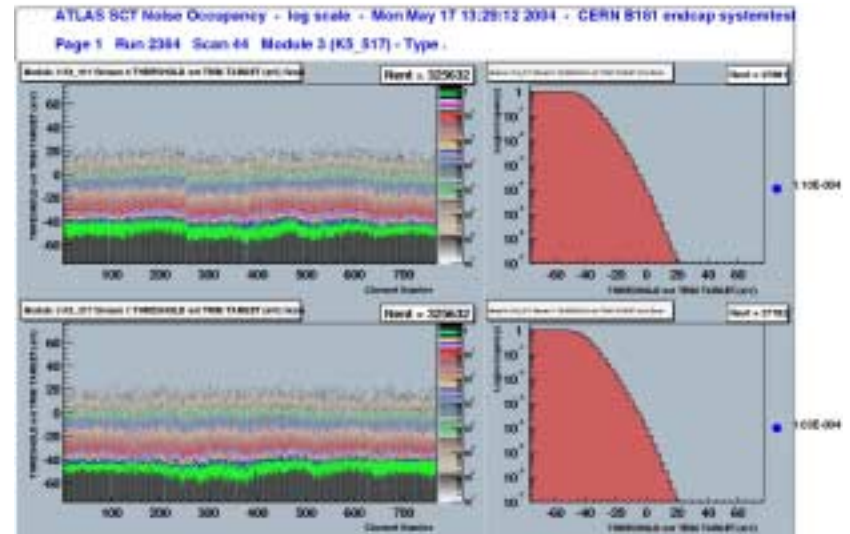
Noise Occ. Scan with no Redundancy Links

- Compared with the SystemTest results where there is little evidence of any discontinuity.
- Threshold scan is also more uniform.
