H.Henschel, I.Tsurin		
Title		
Synchronization and delay supervisor for control signals		
Size	Document Number	Rev
	BST Pad trigger system: Repeater card	0
Date:	Tuesday, June 06, 2006	Sheet 4 of 7

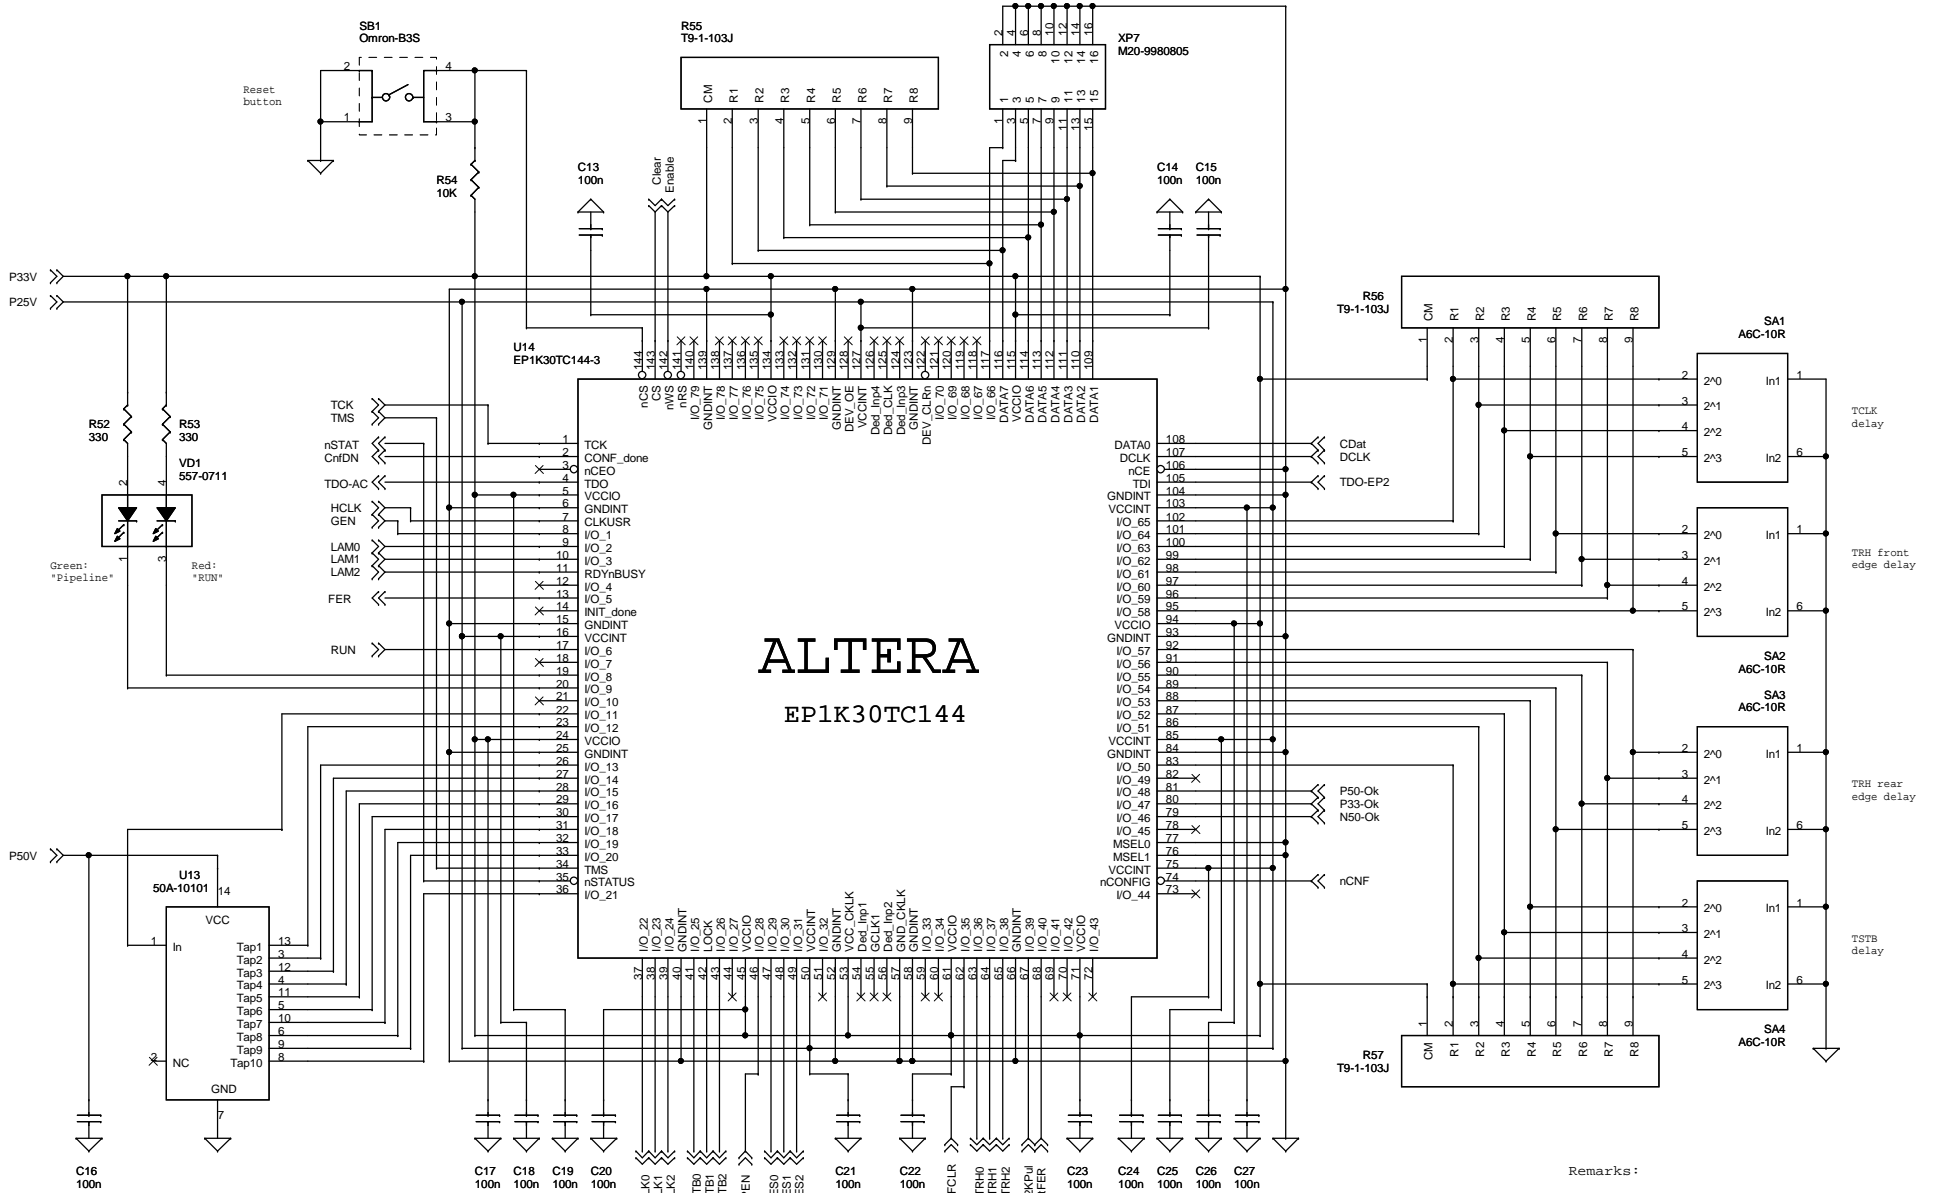
EP1K30TC144

18.08.01 The layout error: the capacitor C16 is inside the "place outline" area of the U13.
