H.Henschel, I.Tsurin	
Title	Data processor and VME interface	
Size	Document Number BST Pad trigger system: Download card	Rev 1
Date: Friday, September 23, 2005	Sheet 2 of 6

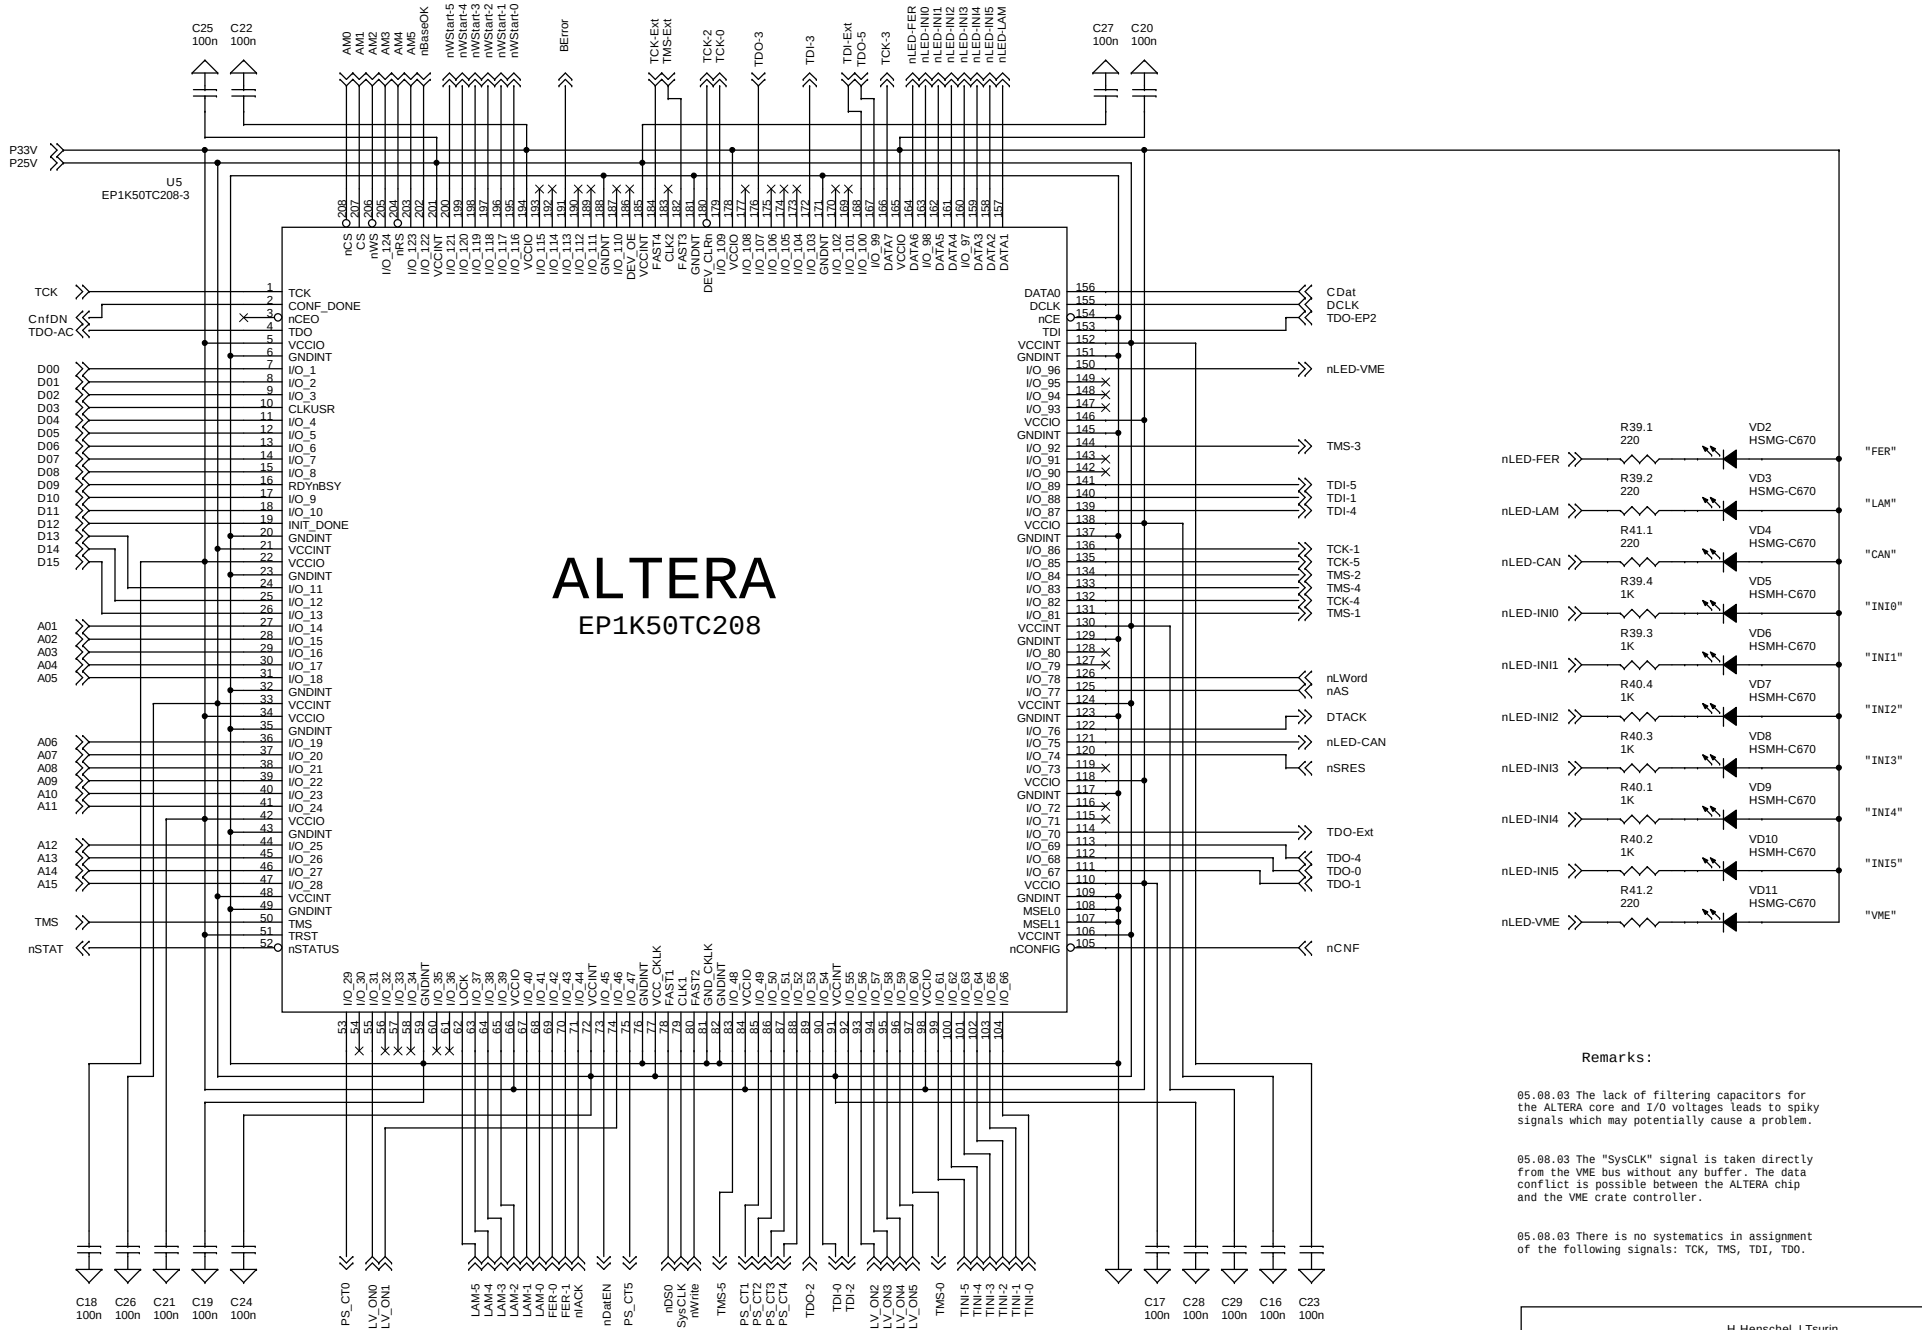
05.08.03 The lack of filtering capacitors for the ALTERA core and I/O voltages leads to spiky signals which may potentially cause a problem.

05.08.03 The "SysCLK" signal is taken directly from the VME bus without any buffer. The data conflict is possible between the ALTERA chip and the VME crate controller.

05.08.03 There is no systematics in assignment of the following signals: TCK, TMS, TDI, TDO.
