H.Henschel, I.Tsurin		
Title		
Front panel input connector and differential receivers for trigger signals		
Size	Document Number	Rev
	BST Pad trigger system: Repeater card	0
Date:	Tuesday, June 06, 2006	Sheet 1 of 7

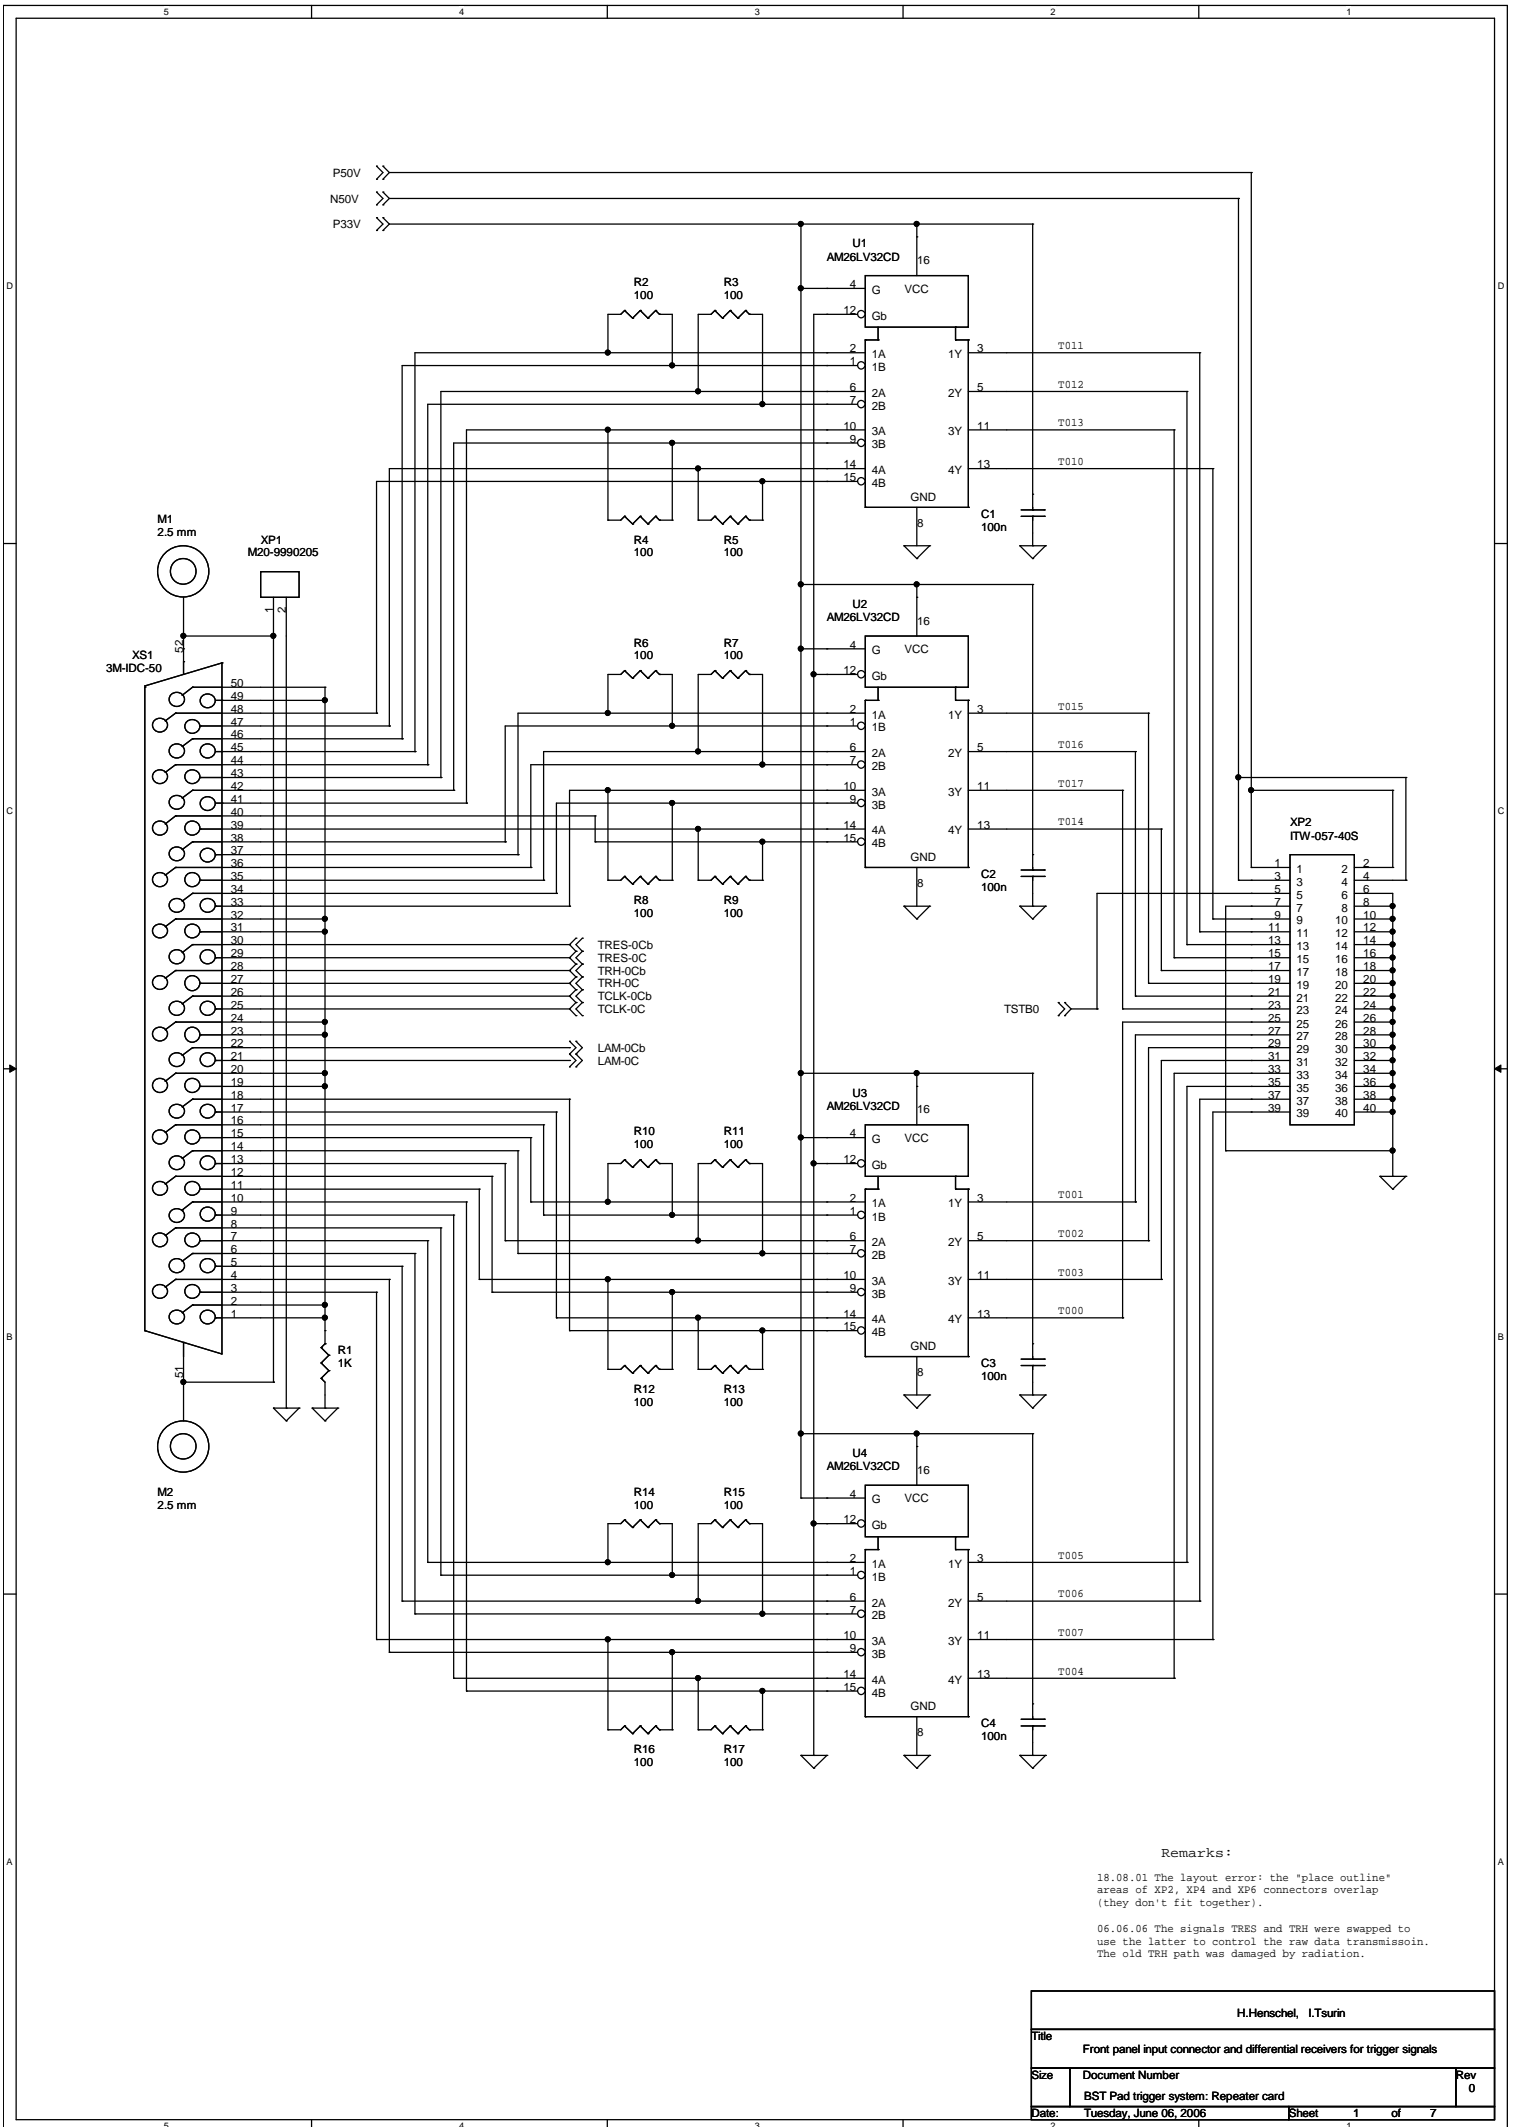
18.08.01 The layout error: the "place outline" areas of XP2, XP4 and XP6 connectors overlap (they don't fit together).

06.06.06 The signals TRES and TRH were swapped to use the latter to control the raw data transmission. The old TRH path was damaged by radiation.
