H.Henschel, I.Tsurin		
Title Auxiliary circuits		
Size	Document Number	Rev 1
BST Pad trigger system: Repeater card		
Date: Friday, September 23, 2005	Sheet 5	of 7

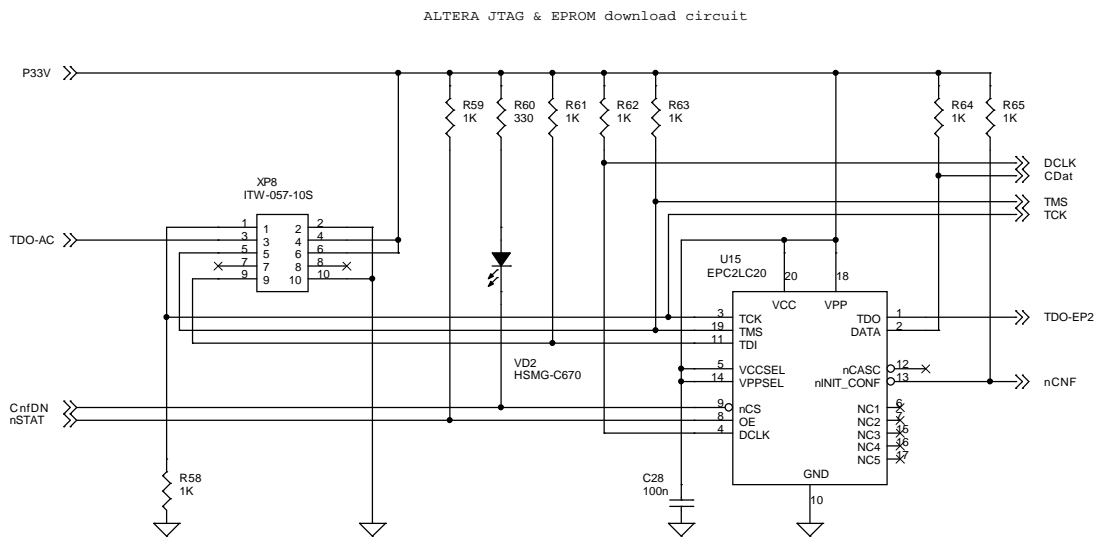
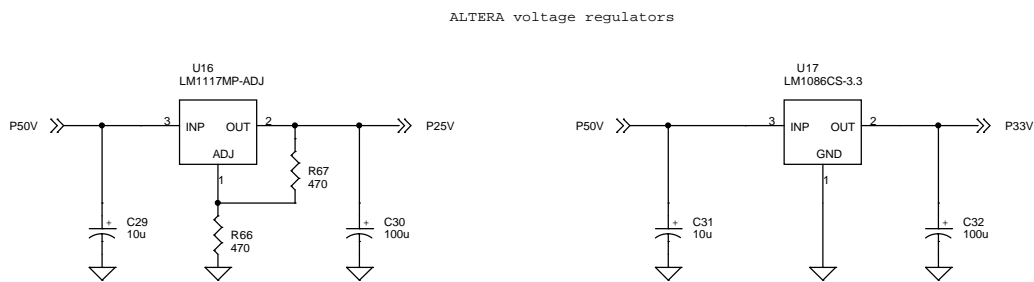
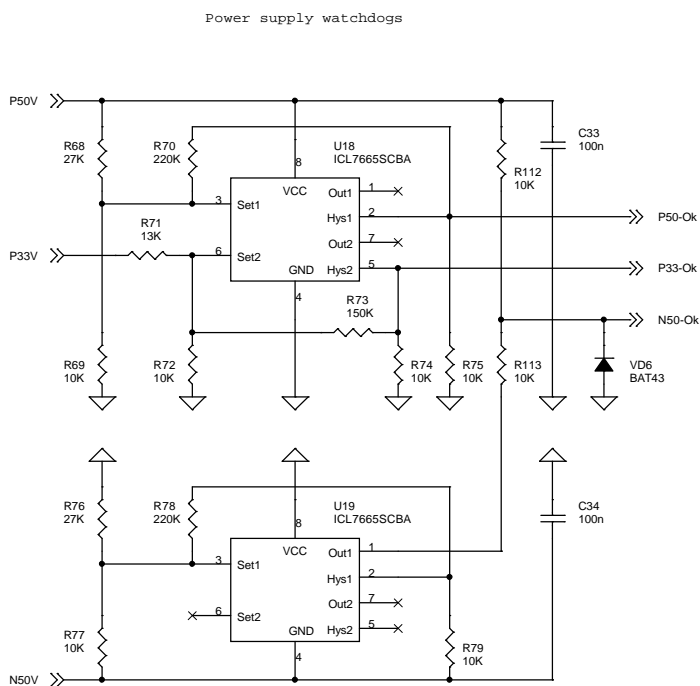
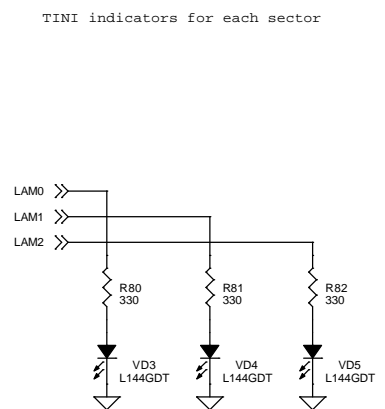
18.08.01 Resistors R112 and R113 and the diode VD6 are not in the actual layout.

18.08.01 The layout error: resistors R58 and R62 are inside the "place outline" area of the XP8.
